# ***Duke's Home Inspections, PLLC***

## **Property Inspection Report**

123 Best Street, Great State, TX 77777  
Inspection prepared for: Number 1 Client  
Real Estate Agent: -

Date of Inspection: 9/14/2022 Time: 10:00 AM  
Age of Home: 2022 Size: 1365  
Weather: Sunny and 78 degrees.  
Home faces North.  
New Construction.  
Customer not present.

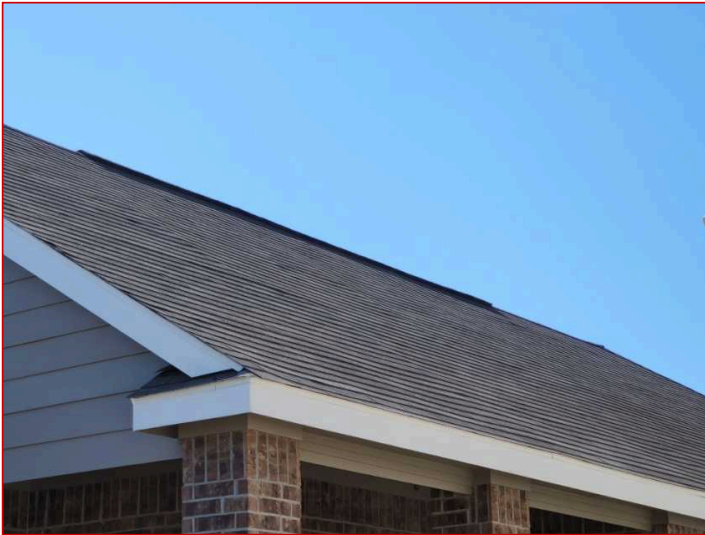
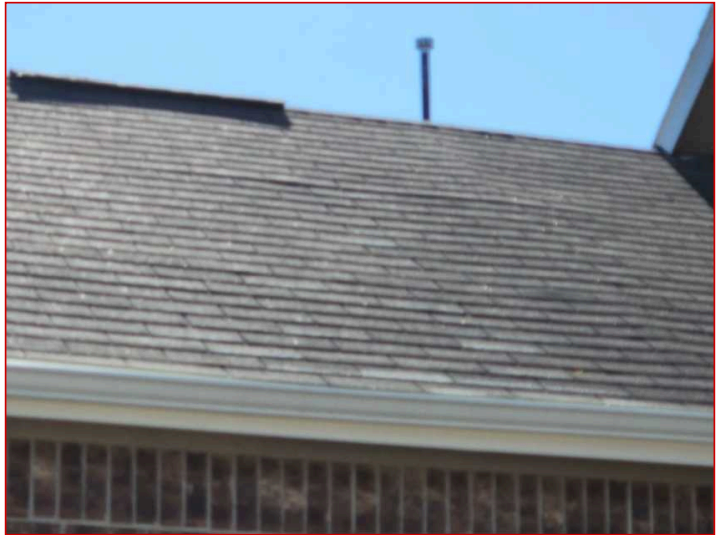
- Asphalt composition shingles noted.

- Viewed roofing system from the ground.

- Satisfactory condition at the time of the inspection. If buyer has any concerns they should have a professional roofer to further evaluate the roofing system or ask seller.
- Recommend all nails, penetrations, flashing be painted and caulked every three to four years. Asphalt or composition shingles have a service life from {15-30} years depending upon the shingle quality, installation and maintenance. Metal roofs tend to have {25-35} year life.
- Inspector could not access the roof due to either roofing material damage, rainy weather, dangerous slope of roof and/or above the reachable height; therefore, the roof was observed from ground level and or eve with ladder. Also with homes being so close together it makes it hard to see areas of the roofing systems. If buyer has any concerns they should have a professional roofer further evaluate the system.

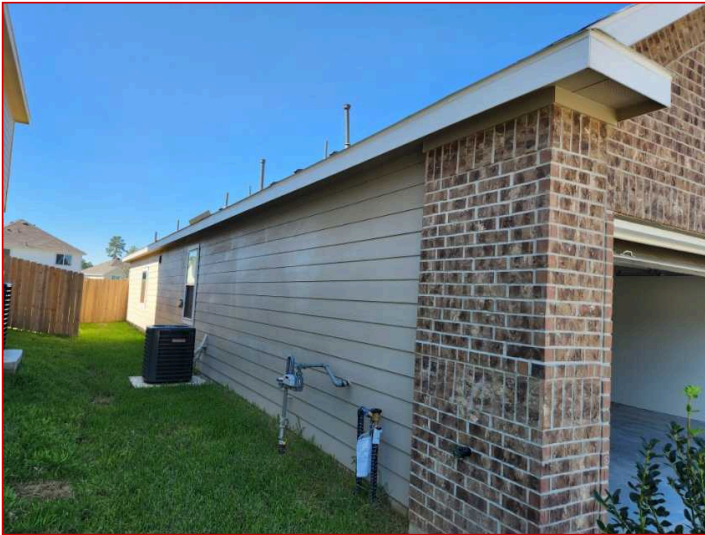
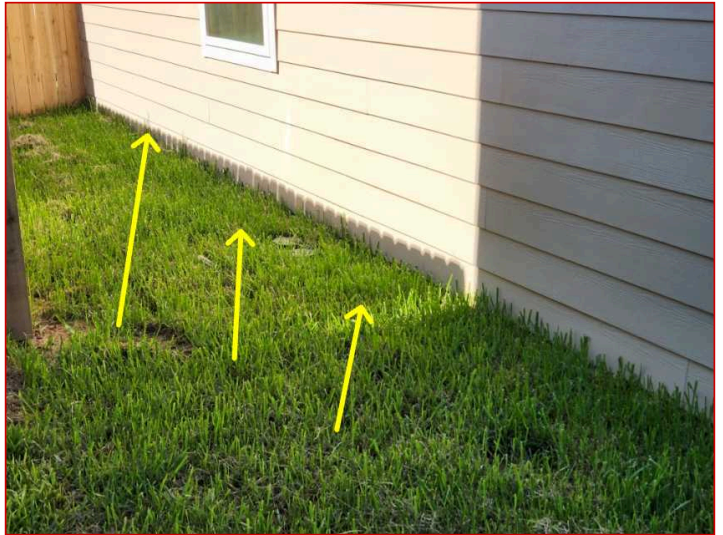
*Earth to siding contact was observed on the exterior siding and should be a minimum of {4"} clearance from the ground for brick/stone {6"} for wood and {8"} for stucco. Common in older homes.*

| Page 8 Item: E | Walls (Interior and Exterior) | • Earth to siding contact was observed on the exterior siding and should be a minimum of {4"} clearance from the ground for brick/stone {6"} for wood and {8"} for stucco. Common in older homes. |

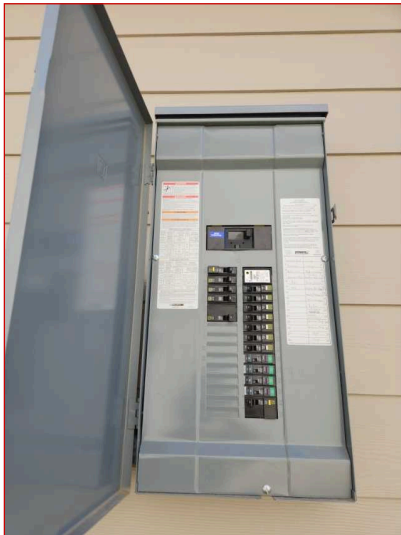
- Panel is located on the exterior wall.
  - 125 amp service.
- Comments:
- Satisfactory at time of inspection

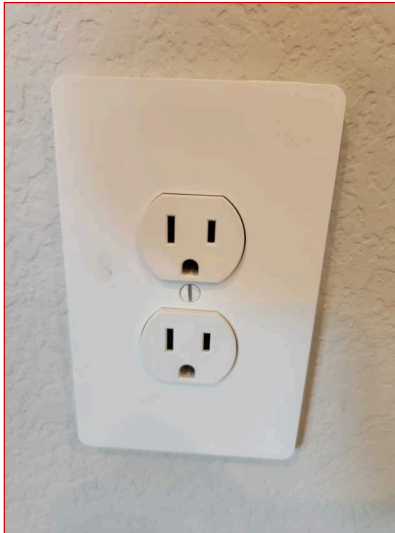
*Outlets in home were not tamper resistant.*

| Page 13 Item: B | Branch Circuits, Connected Devices, and Fixtures | • Outlets in home were not tamper resistant. |

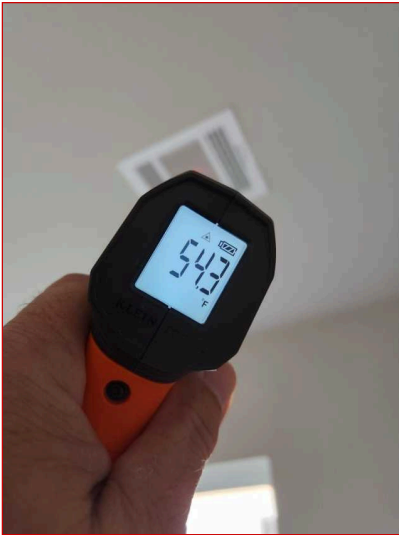
Supply temp 54.3 degrees.

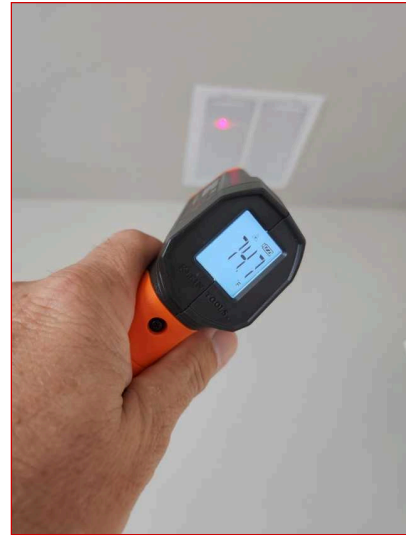
Return temp 74.7 degrees.

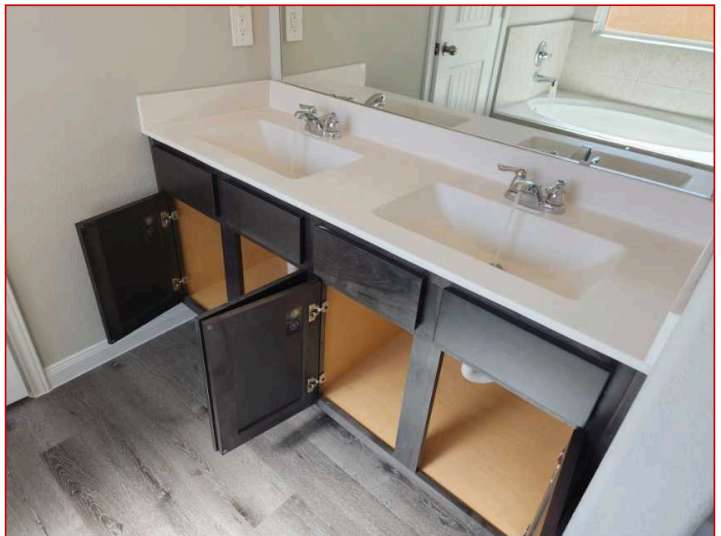
- Home was supplied with pex.

- Water pressure was 53 psi

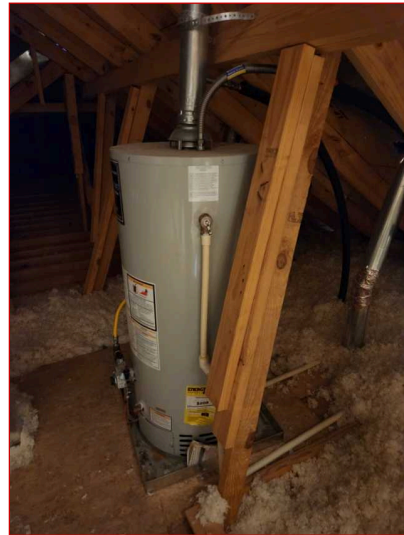
- Water heater is gas fired
- Located in the attic

• 40 gallons

- Satisfactory condition at the time of the inspection.
- The typical life expectancy and/or operational life of a water heater is approximately {10} years depending on usage and maintenance

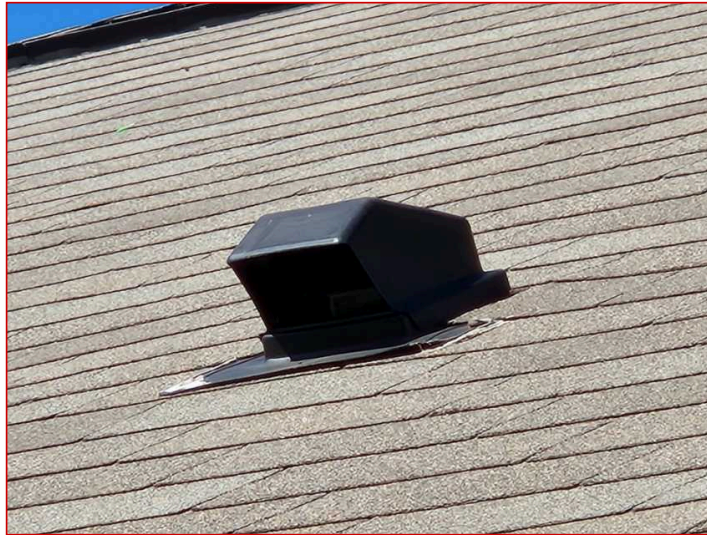
- Recommend dryer duct to be cleaned periodically to keep it clear of lint.
- Satisfactory at time of inspection
- Vent exits out to the roof.

*Recommend dryer duct to be cleaned periodically to keep it clear of lint.*
